THE PRESERVATION OF ST PAUL'S CATHEDRAL & OTHER FAMOUS BUILDINGS

A TEXT BOOK ON THE NEW SCIENCE OF
CONSERVATION, INCLUDING AN
ANALYSIS OF MOVEMENTS IN
HISTORICAL STRUCTURES
PRIOR TO THEIR
FALL

WILLIAM HARVEY

1925

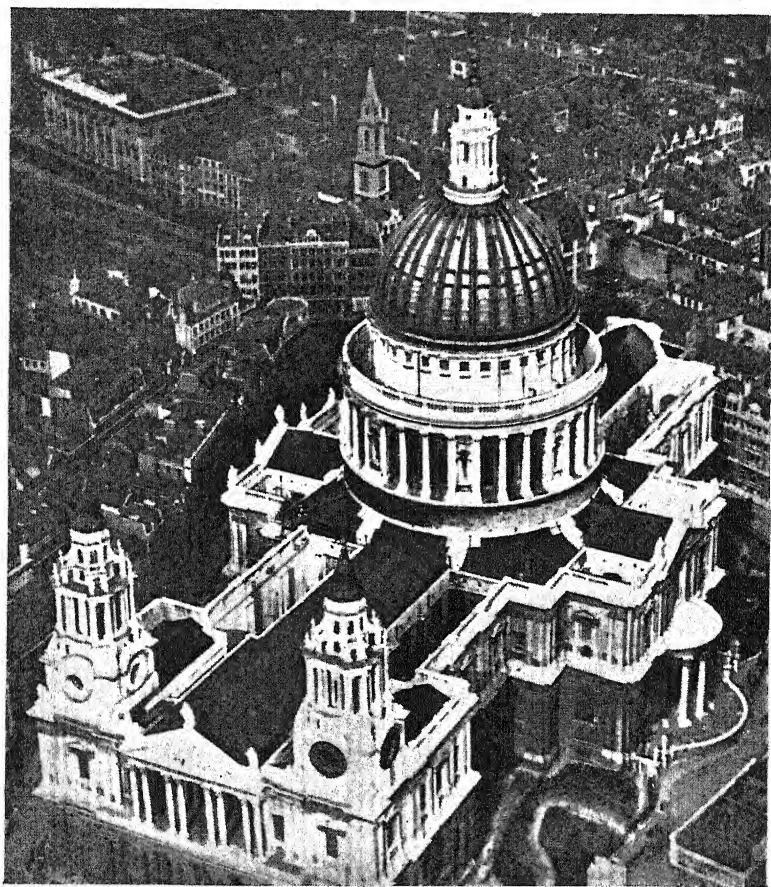
FIG. 34. This view of St. Paul's is interesting as showing how the drum bearing the great dome is in turn supported on its eight piers. The view also reveals the true walls of the nave, transepts, and chancel behind the screen walls which alone are seen from the street.

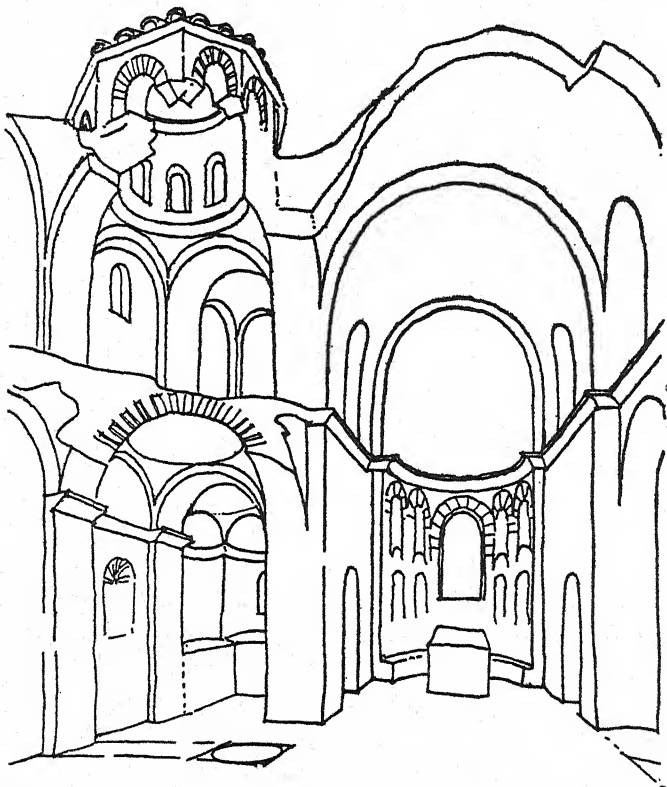
FIG. 58. Ruined Church, Castle Rock, Mistra, Greece. Small dome hanging in the air stuck together with tenacious mortar. From a sketch by the author.
